Cite this article as: Wang Lulu, Liu Yankuan, Fei Yujie, et al. Failure Modes of High Temperature Protective Coating for Aircraft APU Turbine Guide Vanes[J]. Rare Metal Materials and Engineering, 2023, 52(02): 470-477.

# Failure Modes of High Temperature Protective Coating for Aircraft APU Turbine Guide Vanes

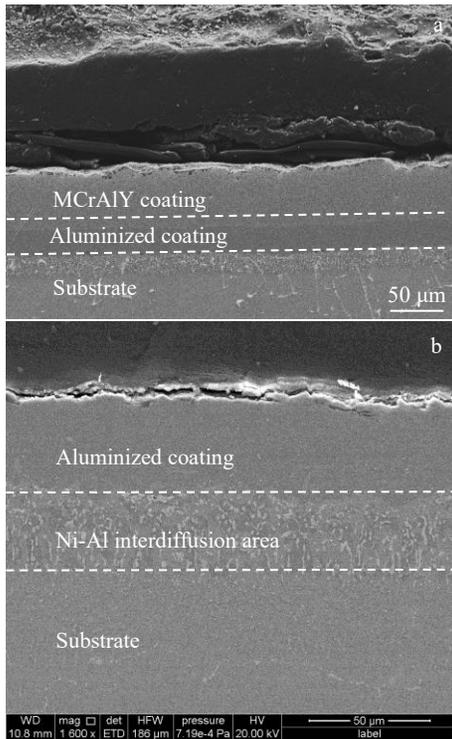
Fig.2 Aluminized coating+MCrAlY coating structure (a) and aluminized coating (b)

As mentioned above, there are two different high temperature protective coating structures in aircraft APU guide vanes. The coatings in the areas of the vane's leading edge, trailing edge, and pressure side are aluminized+MCrAlY structure, named as Al-Si coating (original thickness of about 50 μm)+MCrAlY metal coating (original thickness of about 80 μm) prepared by EB-PVD (Fig.2a); while the vane's suction side is a single Al-Si coating (50 μm), as shown in Fig.2b. It should be noted that the coating thickness presented in Fig. 2 is not the original thickness of the as-prepared coating, because the guide vane coating may be subjected to high temperature oxidation, high temperature thermal corrosion, thermal shock and particle impact under the working condition of the APU. The thickness of the coating decreases due to the damage such as corrosion and high temperature ablation, and the thickness of the aluminized coating may increase due to the interdiffusion of elements between the coating and the substrate, thus forming a Ni-Al interdiffusion layer, as shown in Fig.2b.

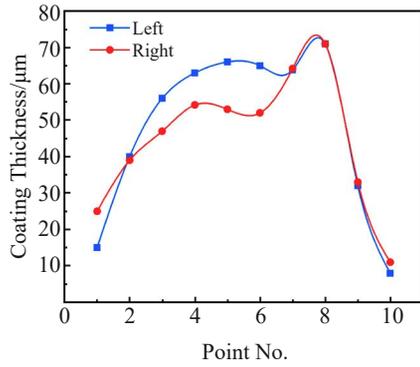
Fig.4 Variation curves of coating thickness on failed vanes

The remaining thickness of the vane's high temperature protective coating is an important reference to reflect the actual service environment and overall performance changes of the component. Therefore, it is necessary to measure and analyze the thickness of the APU high pressure turbine guide vanes. As shown in Fig. 3, a relatively complete discarded APU guide vane is selected to measure the thickness of the MCrAlY coating in different areas. The thickness of MCrAlY coating is measured by SEM from point 1 to 10, following the sequence of trailing edge – pressure side – leading edge. According to the results shown in Fig.4, it can be seen that the thickness of MCrAlY coating on APU guide vane increases first and then decreases from trailing edge to pressure side and then to leading edge. The coating thickness near the starting point 1 (trailing edge) is relatively low, about 20  $\mu$ m, and then as the test point moves forward, the thickness gradually increases. The maximum value of the thickness is near point 8 (the transition area between the pressure side and the inner side of the leading edge), and the maximum value is about 70  $\mu$ m. After that, the coating thickness decreases rapidly, and the minimum thickness is near point 10 (outside the leading

edge), about 10  $\mu\text{m}$ . Through the comparative analysis of several APU high pressure turbine guide vanes with the same model, it is found that the variation trend of coating thickness is common.

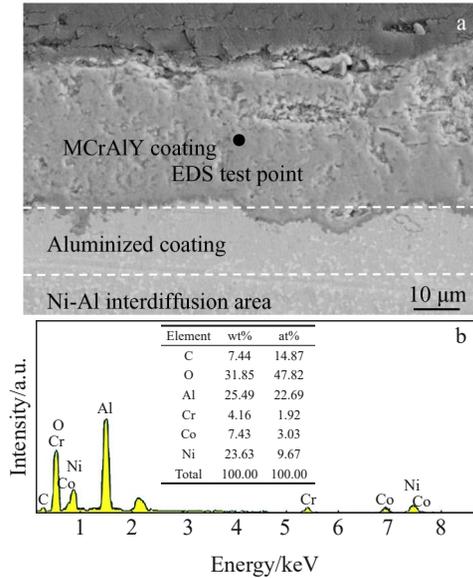
Fig.5 Micromorphology (a) and EDS analysis result (b) of MCrAlY coating on the trailing edge of the vane

Fig.5a shows the microstructure of the MCrAlY coating at point 1 (trailing edge). Combined with the EDS analysis result in Fig. 5b, it can be seen that the oxidation degree of the MCrAlY coating at the vane's trailing edge is more serious, and the oxygen atom content is about 31.85wt%. Meanwhile, the existence of Al-Si coating and Ni-Al interdiffusion zone can be observed in Fig. 5a, indicating that most of the oxidation of coating's trailing edge happens in the MCrAlY coating, and does not involve the internal structure. However, a large number of cracks, pores and oxidized areas can be clearly observed inside the MCrAlY coating, and the residual coating thickness in this area is relatively low (20  $\mu\text{m}$ ), which further proves that the degree of oxidation of the vane's trailing edge is more serious, resulting in coating burnout corrosion and spalling.

By comparison with other APU guide vane components that have failed in actual work, it can be found that the substrate has been exposed after the coating spallation due to the serious oxidation level of the trailing edge. In some certain

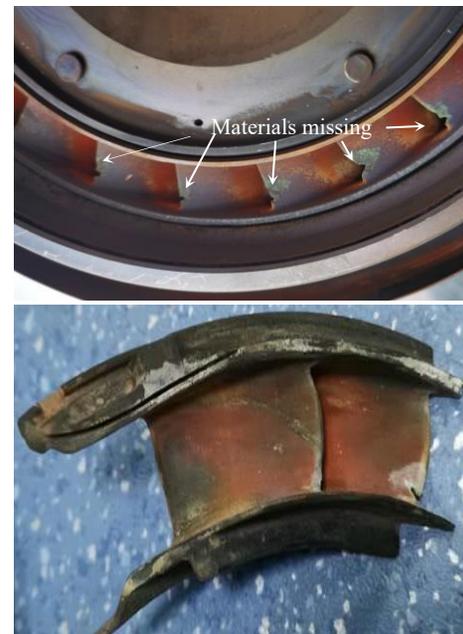
Fig.6 Material missing from the trailing edge of APU guide vane due to ablation

areas, the substrate has even been ablated, resulting in material missing, as shown in Fig.6.

It should be noted that although the micro-cracks appearing here may be caused by thermal fatigue of the coating material, the phenomenon is mainly affected by high temperature ablation, because the thickness of the coating has been significantly reduced. In addition, as the MCrAlY layer and the Al-Si layer are both metal coatings, the difference in coefficient of thermal expansion (CTE) between them is very small; according to Slámečka et al's research<sup>[26]</sup>, the calculated CTE of MCrAlY coating is around  $15.0 \times 10^{-6} \text{ K}^{-1}$ , while the

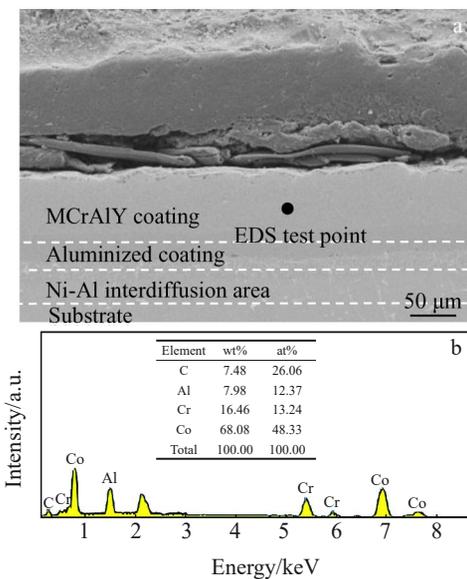
Fig.7 Micromorphology (a) and EDS analysis result (b) of MCrAlY coating in vane's basin area

The microstructure morphology of MCrAlY coating at point 7 (pressure side) is shown in Fig.7a. Combined with the EDS analysis results shown in Fig.7b, it can be seen that the oxidation degree of the MCrAlY coating at the vane's pressure side is relatively low, with almost no oxygen element, and only the constituent elements of MCrAlY materials such as Co, Cr, and Al can be found. Note that the C element detected in the energy spectrum analysis results is the interference of the inlaid resin material, while the Y element is not detected in Fig.7b because the content of the Y element in MCrAlY is low (only 0.5wt%), and conventional energy spectrometry instruments cannot accurately detect the presence of elements at this content level. Furthermore, the complete MCrAlY coating, Al-Si coating and Ni-Al interdiffusion zone can be observed in Fig.7a. Compared with the above-mentioned vane's trailing edge area, no obvious cracks and pores are observed in the MCrAlY coating in the pressure side area, and the coating's morphology and density are at great level with the thickness of about 65  $\mu\text{m}$ , which is close to the original MCrAlY coating thickness value, indicating no oxidative ablation, spallation or other damage.

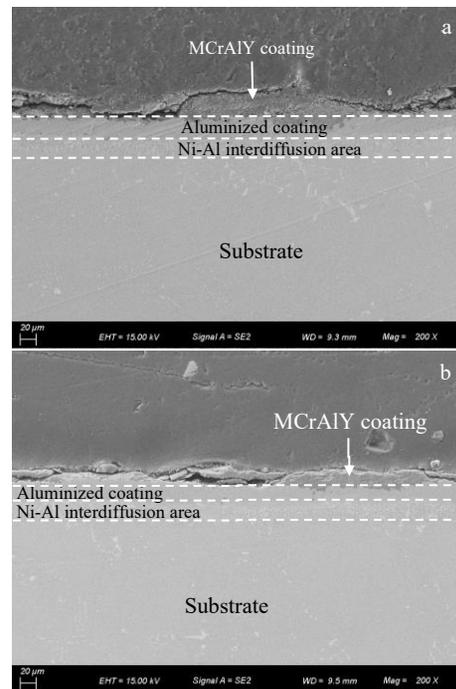
Fig.9 Micromorphologies of MCrAlY coating in different areas at point 10 of the leading edge of vane

Fig.9a and Fig.9b show the microstructure morphologies of MCrAlY coating at point 10 (leading edge). From these two figures, it can be obviously judged that the damage degree of MCrAlY coating at APU guide vane's leading edge is the most serious. Not only the MCrAlY coating in some certain areas is missing, but there are also oxidation regions of aluminized coating.

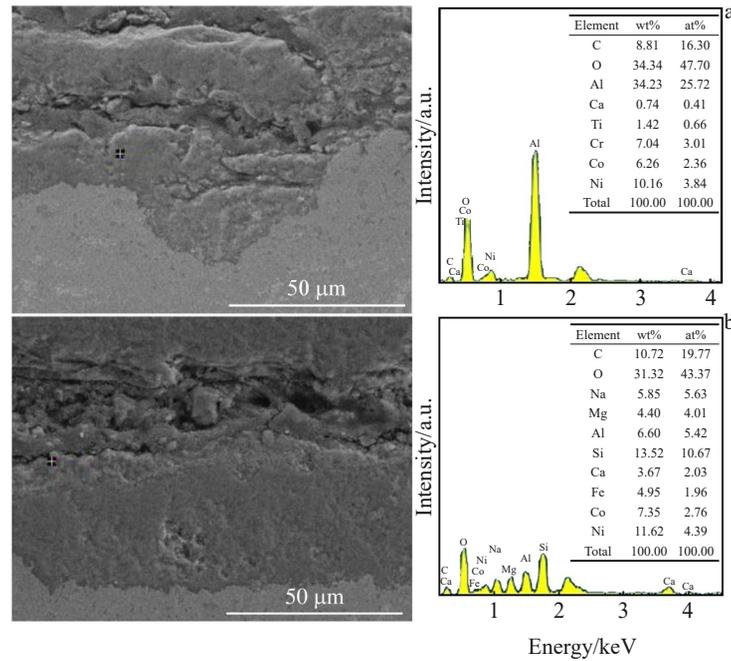
Fig.10 EDS analysis results of oxidation corrosion products on different surface areas of MCrAlY coating at the leading edge of the vane

Fig.10a and Fig.10b, it is found that the coating's failure mode in this area is not limited to high temperature oxidation corrosion. According to the two figures, there are certain contents of Ca, Mg, Si and other elements in the MCrAlY coating on the leading edge surface, which indicates that there is CMAS corrosion in the coating at the same time along with the oxidation corrosion. This result is exactly consistent with the actual working condition of APU turbine guide vanes. During APU operation, the leading edge is on the scouring surface of the high temperature airflow, and it can be eroded by dusts, sands, and ashes in the atmosphere and impurities in fuel, namely, CMAS corrosion.

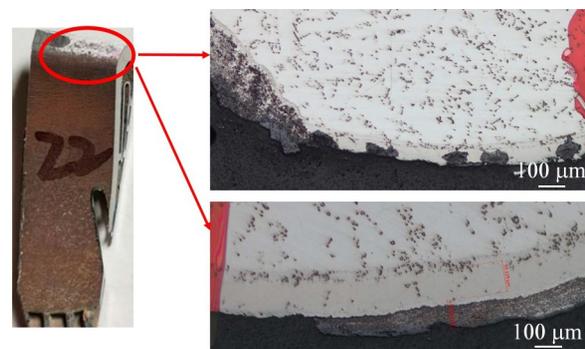
Fig.12 Coating thinning and spallation caused by CMAS corrosion-high temperature oxidation coupling effect

coating is lower than that of the trailing edge<sup>[28,34]</sup>, so the effect of oxidation corrosion is not obvious. Taking the above factors into consideration, the phenomenon of the smallest coating thickness and the most serious coating damage in the leading edge area of the vane (Fig.12) can be summarized as the coupling effect of predominant CMAS

corrosion and high temperature oxidation corrosion as a supplement.
