Cite this article as: Wang Lulu, Liu Yankuan, Fei Yujie, et al. Failure Modes of High Temperature Protective Coating for Aircraft APU Turbine Guide Vanes[J]. Rare Metal Materials and Engineering, 2023, 52(02): 470-477.

# Failure Modes of High Temperature Protective Coating for Aircraft APU Turbine Guide Vanes

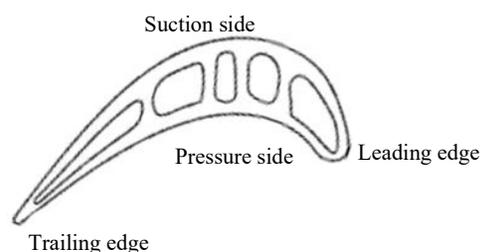
The failure components of the first-stage guide vane of APU high-pressure turbine of aircraft actually operated by airlines were taken as the research object. The vane configuration and division are shown in Fig.1. The substrate of the vane was a nickel-based superalloy, and the surface of the substrate was covered with high temperature protective coating. The leading edge, trailing edge and the pressure side of the coating were aluminized+MCrAlY structure, namely Al-

Fig.1 Schematic diagram of a certain type of APU high-pressure turbine guide vane

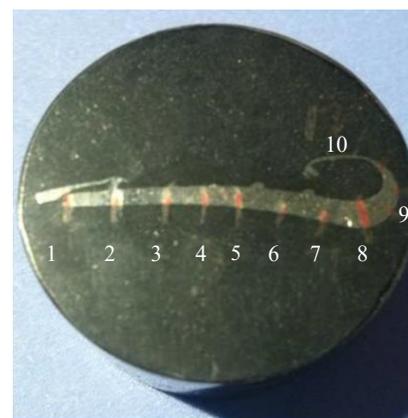
The remaining thickness of the vane's high temperature protective coating is an important reference to reflect the actual service environment and overall performance changes of the component. Therefore, it is necessary to measure and analyze the thickness of the APU high pressure turbine guide vanes. As shown in Fig. 3, a relatively complete discarded APU guide vane is selected to measure the thickness of the MCrAlY coating in different areas. The thickness of MCrAlY coating is measured by SEM from point 1 to 10, following the sequence of trailing edge – pressure side – leading edge. According to the results shown in Fig.4, it can be seen that the thickness of MCrAlY coating on APU guide vane increases first and then decreases from trailing edge to pressure side and then to leading edge. The coating thickness near the starting point 1 (trailing edge) is relatively low, about 20  $\mu$ m, and then as the test point moves forward, the thickness gradually increases. The maximum value of the thickness is near point 8 (the transition area between the pressure side and the inner side of the leading edge), and the maximum value is about 70  $\mu$ m. After that, the coating thickness decreases rapidly, and the minimum thickness is near point 10 (outside the leading

Fig.3 Inlaid vane specimen and its selected marking points

edge), about 10  $\mu\text{m}$ . Through the comparative analysis of several APU high pressure turbine guide vanes with the same model, it is found that the variation trend of coating thickness is common.

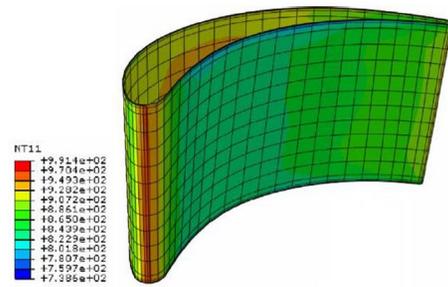
At the same time, as the vane's leading edge is directly scoured by the airflow, this position is the highest point of the flame temperature that the entire vane is subjected to during service<sup>[28]</sup> (as shown in Fig. 11), so there is also a certain degree of oxidation corrosion in this area itself. However, due to the better design and quality of ventilation holes in this area, the temperature of the

Fig.11 Temperature distribution of high temperature airflow in the vane area<sup>[28]</sup>
