Effect of Intermetallic Compounds on the Fracture Behavior of Mg/Al Laminated Composite Fabricated by Accumulative Roll Bonding

Abstract: We observed massive cracked intermetallic compounds at the interface of the laminated Mg/Al composite fabricated by accumulative roll bonding and investigated the effect of the compounds on the fracture process of the Mg/Al composite. Scanning electron microscopy observation reveals that these cracked intermetallic compounds dominate the fracture behavior of the accumulative roll bonded Mg/Al composite during uniaxial tensile testing. The results indicate that obvious Mg/Al interface delamination is promoted by the cracked intermetallic compounds, and the cracks propagate into the softer Mg layer and lead to the rupture of Mg layer. These two factors result in the premature failure of the laminated Mg/Al composite.

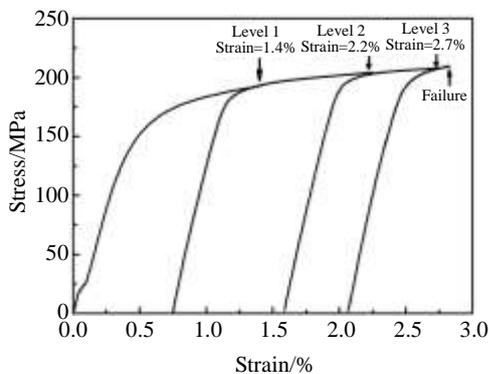
Fig.1 Stepped engineering stress-strain curves of the uniaxial tensile test

The stepped engineering stress-strain curves are plotted in Fig.1. The composite shows a very limited elongation, which is similar to our previous work [14]. Fig.2 displays the SEM microstructure of the longitudinal plane of the specimen before the tensile test. A large number of massive intermetallic compound particles (indicated by the black arrows) with obvious cracks are observed at the Mg/Al interface. The particle was characterized by EDS line analysis (Fig.3) and identified as Al_3Mg_2 at the side of Al layer and $Mg_{17}Al_{12}$ next to the Mg layer. The similar results were reported in Chen's work [10]. The particles formed between layers are thought to be due to the large rolling strain and the high temperature [15], which accelerate the diffusion at the Mg/Al interface. These intermetallic compounds nucleate and grow rapidly during

have been propagated into the center of Mg layer and a severe local 45° shear deformation could be observed at strain level 2, as shown in Fig.4e. Simultaneously, new cracks, pointed out by the black arrows in Fig.4h, occur on both intermetallic compounds “1” and “2”. As similar as Matsumoto’s work [8], the interface crack could readily propagate in the intermetallic compounds and finally to an interface delamination. With strain increasing up to strain level 3, crack width of the Mg layer keeps increasing and the Mg layer is completely ruptured, which are shown in Fig.4f. Accordingly, the sample shows a very limited strain increment and fails in a sudden manner after strain level 3, as shown in Fig.1.

Moreover, it is interesting that the slope in the first curve for strain level 1 is different from the slope for the other strain levels, as shown in Fig.1. According to the present work, one possible explanation for this behavior could be proposed as: the delamination of Mg/Al interface occurs after the global yielding (or at the strain level 1). This might result from cracked intermetallic compounds and different deformation properties of Mg and Al layer. When loading further, the Al layer mainly endures loading while the Mg layer yields. Thus, the slope for the following strain level is steeper than the slope of the

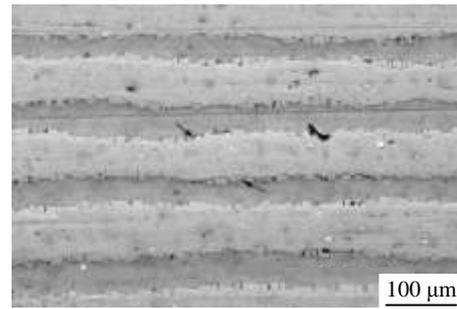
Fig.2 SEM microstructure on the longitudinal plane of the tensile sample before tensile test

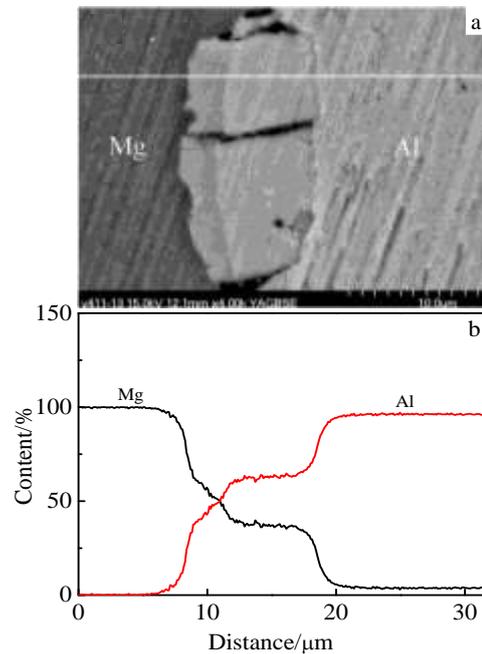
Fig.3 SEM image of an intermetallic compound (a) and EDS line analysis along the intermetallic compound (b)

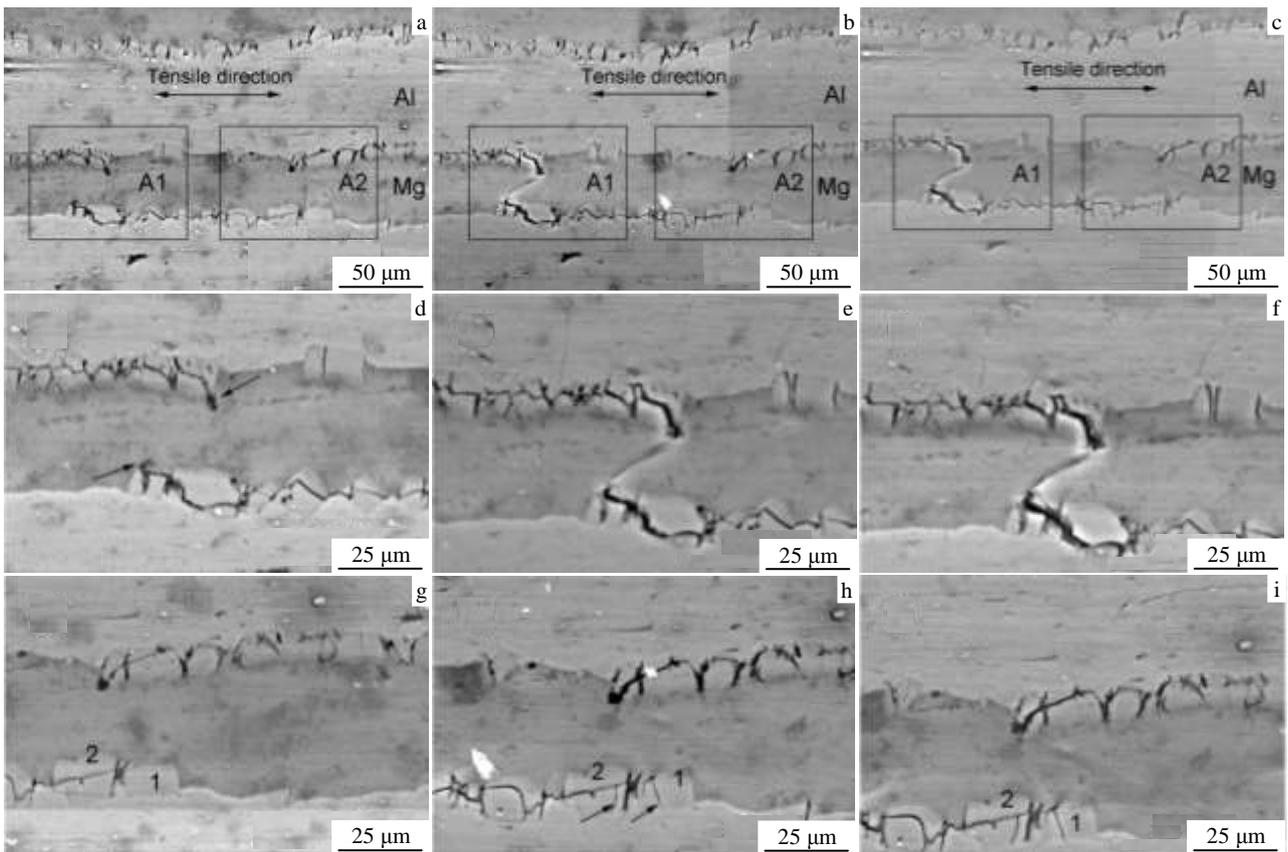
Fig.4 SEM microstructures of the selected observation area at different strain levels: (a) level 1, (b) level 2, and (c) level 3; (d, e, f) and (g, h, i): enlarged regions “A1” and “A2” in Fig.4a~Fig.4c, respectively

The detailed tensile fracture behavior of the ARBed Mg/Al composite is presented in Fig.4. At strain level 1, an obvious crack is observed along the Mg/Al interface, possibly because of the linkage of cracks in neighbouring intermetallic compounds (see Fig.4a and 4d). This interface crack has not propagated into the intermetallic compounds “1” and “2” which are located ahead of the interface crack-tip at this strain level (Fig.4g). It is worth noting that some incipient crack points marked by the black arrows in Fig.4d are observed in the Mg layer, at the region close to the crack opening of the intermetallic compounds. Above observations show that the pre-existing cracks of the intermetallic compounds cause a crack initiation in the Mg layer at this strain level. On further straining from strain level 1 to strain level 2, the newly introduced micro-cracks locating at the edge of the Mg layer

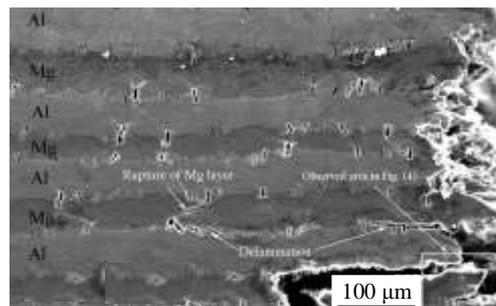
Fig.5 Fracture profile of the tensile specimen after failure

Fig.5 shows a SEM image taken at the area close to the fracture. Many cracks in Mg layers and Mg/Al interface delamination are observed in this area near the main fracture. Thus, one can conclude that a number of ruptures in Mg layers and interface delaminations take place simultaneously at different locations in the sample during initial straining. Then some of them propagate together and cause the sudden failure of the sample. Fig.6 presents the fracture profile of the tensile sample along the transverse direction after the tensile test. A clearer crack could be observed along the Mg/Al interface. It is evident that the intermetallic compounds do also affect the fracture behavior of the Mg/Al laminated composite along the

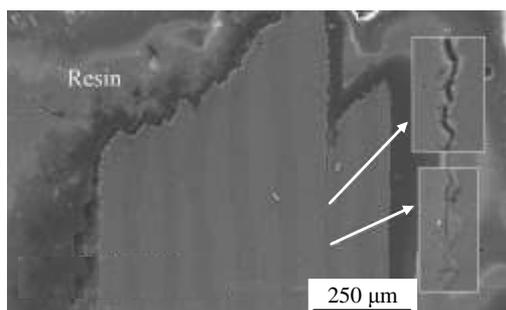
Fig.6 Fracture profile of the tensile specimen along the transverse direction after failure

transverse direction, which is the same as that along the rolling direction.
